# Catheter Fragmentation

Risk prevention by avoiding  
reinsertion of IV catheters

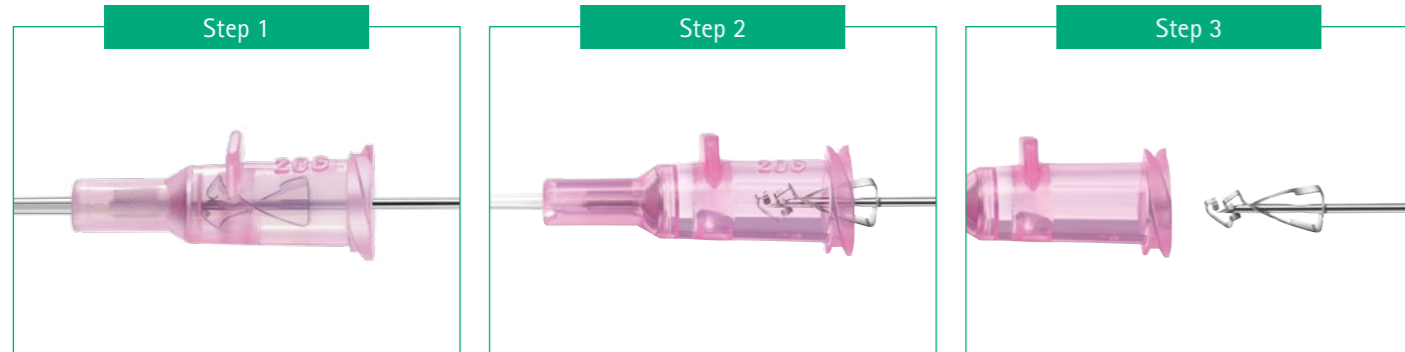
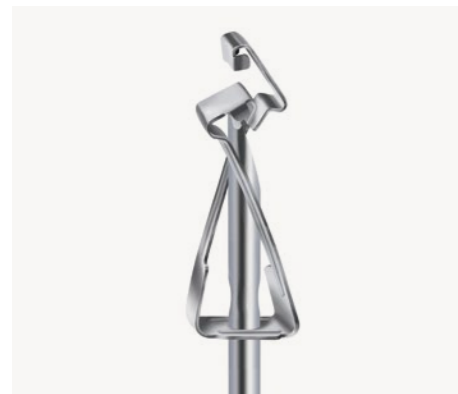
### Passive Safety Shield

The B. Braun Safety IV Catheters have a passive safety mechanism that is automatically activated once the needle is withdrawn out of the catheter hub, making reinsertion of the needle not possible.

- is a passive, fully automatic protection of the needle tip
- It deploys automatically and requires no user activation
- Cannot be bypassed
- Designed to eliminate needlestick injuries and related infections<sup>9,10</sup>
- Passive Safety is most effective at preventing needlestick injuries<sup>9,10</sup>
- Passive Safety is proven to be better than a semi-automatic 'push-button' safety shield or manually sliding shield<sup>10</sup>
